THE CALIFORNIA EARTHQUAKE OF APRIL 18, 1906

STATE EARTHQUAKE INVESTIGATION COMMISSION

IN TWO VOLUMES AND ATLAS

ANDREW C. LAWSON, CHAIRMAN

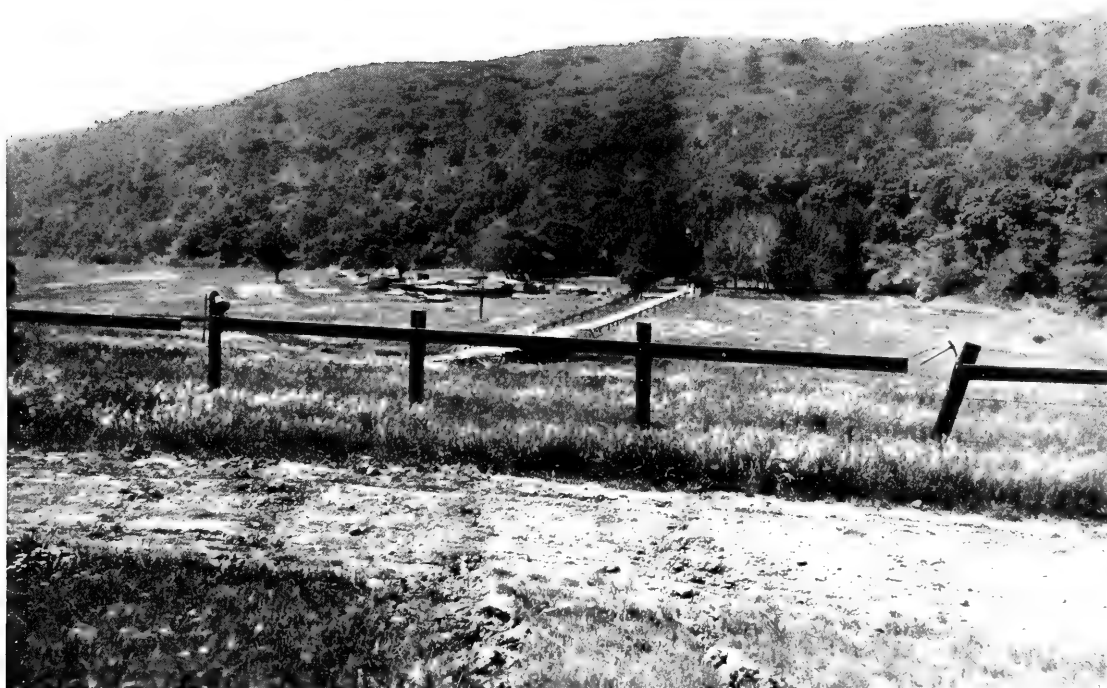
A. The Rift valley between San Andreas Lake and Crystal Springs, looking southwest. Fault-trace parallel to fence about 50 feet beyond. Auxiliary cracks in the foreground at an angle of 40° with it. J. C. B.

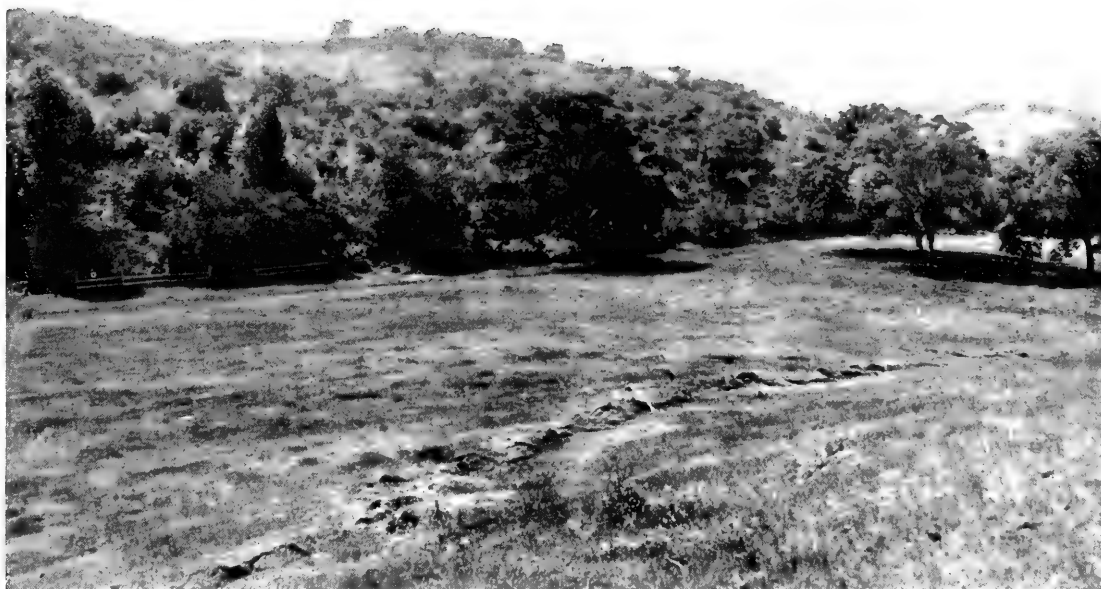
B. The Rift valley 5 miles west of Stanford University. Fault-trace in foreground. Per J. C. B.

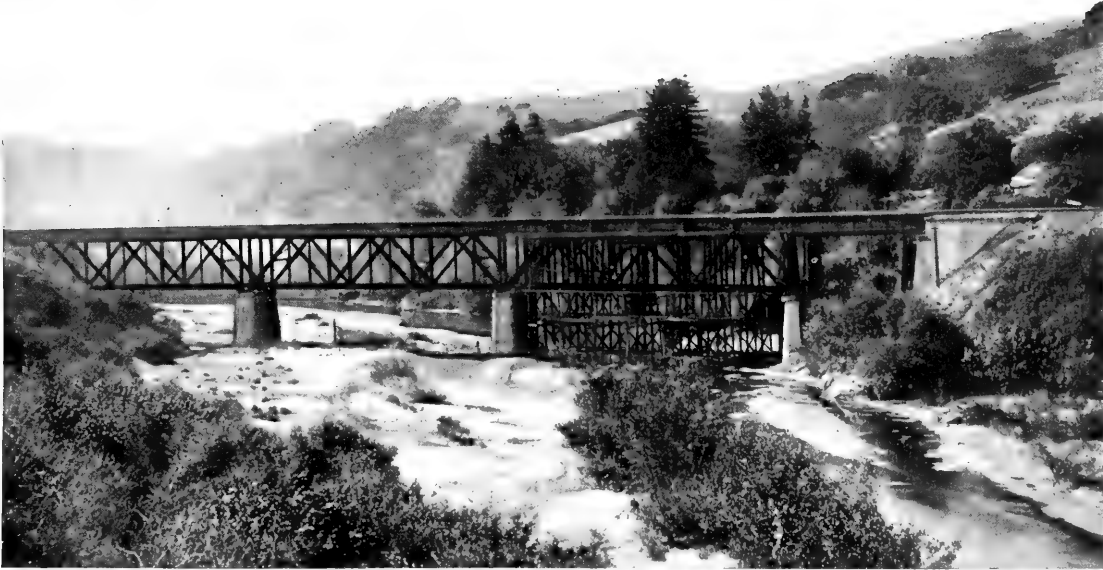
The earthquake of April 18, 1906, opened and displaced the walls of the old fault along the Rift as far south as the town of San Juan in San Benito County. The fault-trace passes directly under the western span of the Southern Pacific Railroad bridge across San Juan River, as shown by the displacement of the piers at the end of the bridge, a distance of 3.5 feet. For a distance of nearly half a mile on either side of the bridge, the river has established itself in the Rift. To the northwest the steep slopes of Mount Pajaro facing the canyon do not show any regular fissure. This does not, however, indicate any discontinuity in the fault, for the surface of the whole mountain is more or less broken by auxiliary cracks, secondary fissures, and slides.

A. The Rift followed by the Pajaro River at Chittenden. Dislocated bridge supported by false work. H. W. F.

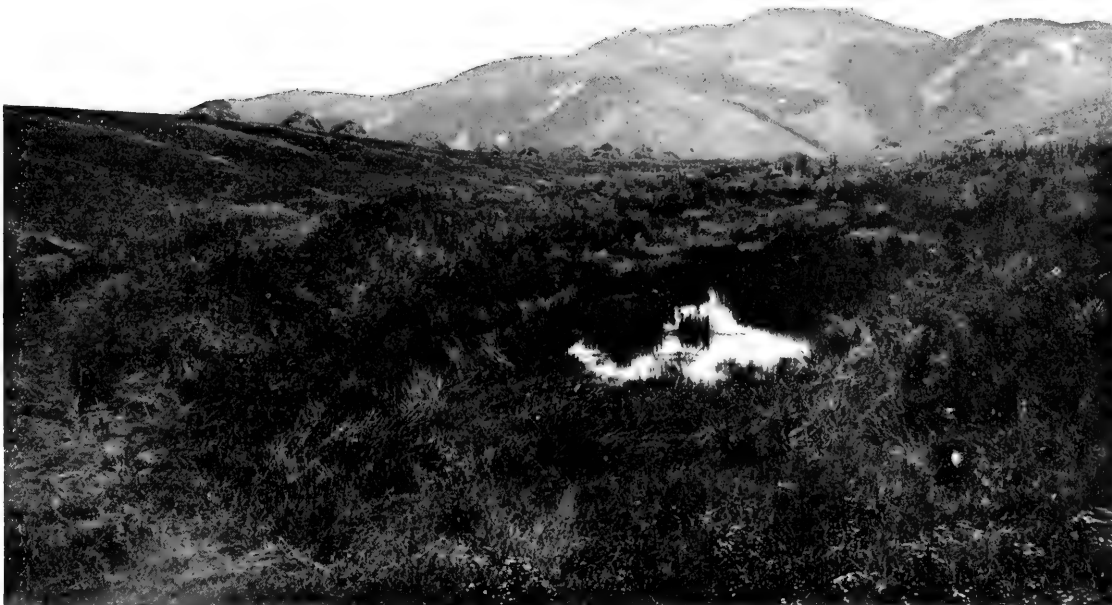
Southeast over the hills from the point where the Rift leaves the river, the characteristic features of the Rift make their appearance. It is marked by a small pond (plate 17B), springs, and a more or less continuous ridge with its steeper face toward the southwest. The fissure of the recent earthquake follows this series of features (plate 18A), and, at a point halfway between the bridge and San Juan, there is shown in a broken fence a horizontal displacement of 4 feet. A mile before reaching San Juan, granitic rocks are exposed upon the southwest side of the Rift. Shortly beyond this point the Rift leaves the hills and traverses the western edge of the valley of the San Benito River. The ridge which we have been following is now lost in the level floor of the valley, but as far as traceable its course is directly toward the low bluff upon the eastern edge of the town of San Juan. The fissure of the recent earthquake is to be seen where it crosses the road 0.5 mile northwest of San Juan, but has not been noted farther along the old Rift line. It appears to bend more easterly, and this probably connects it with the disturbances of the earth between Hollister and San Juan. Mr. Abbe, of San Juan, states that the earthquake of 1890 opened the old Rift and that the displacement of the walls, tho small, was in the same direction as in the recent earthquake.

B. The Rift a mile southeast of Chittenden. Pond on upper slope of hill. H. W. F.

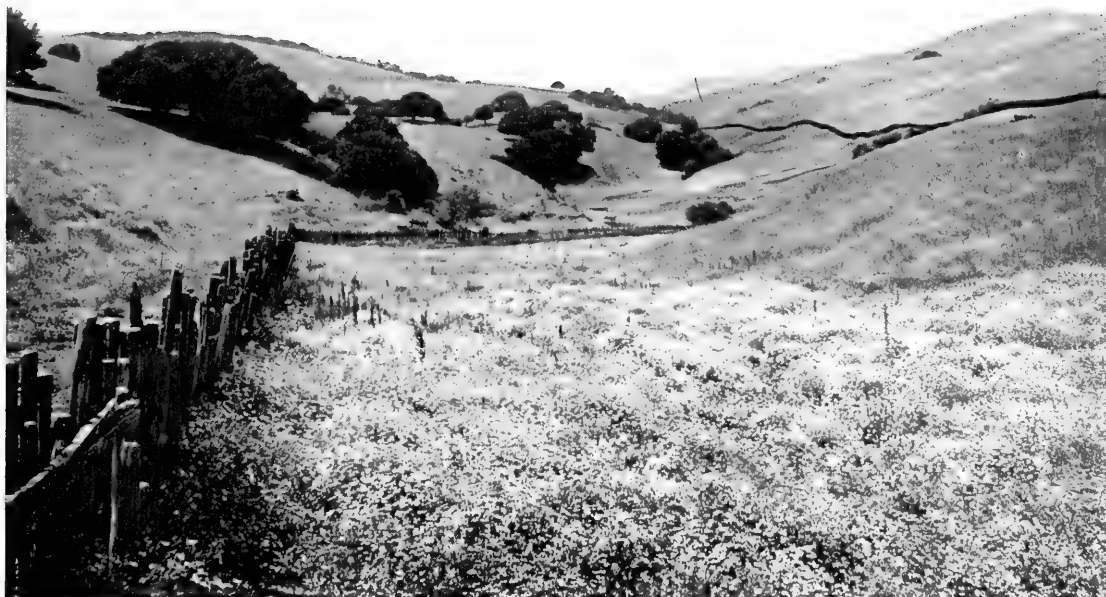
A. Looking northwest along the Rift 3 miles southeast of Chittenden. H. W. F.

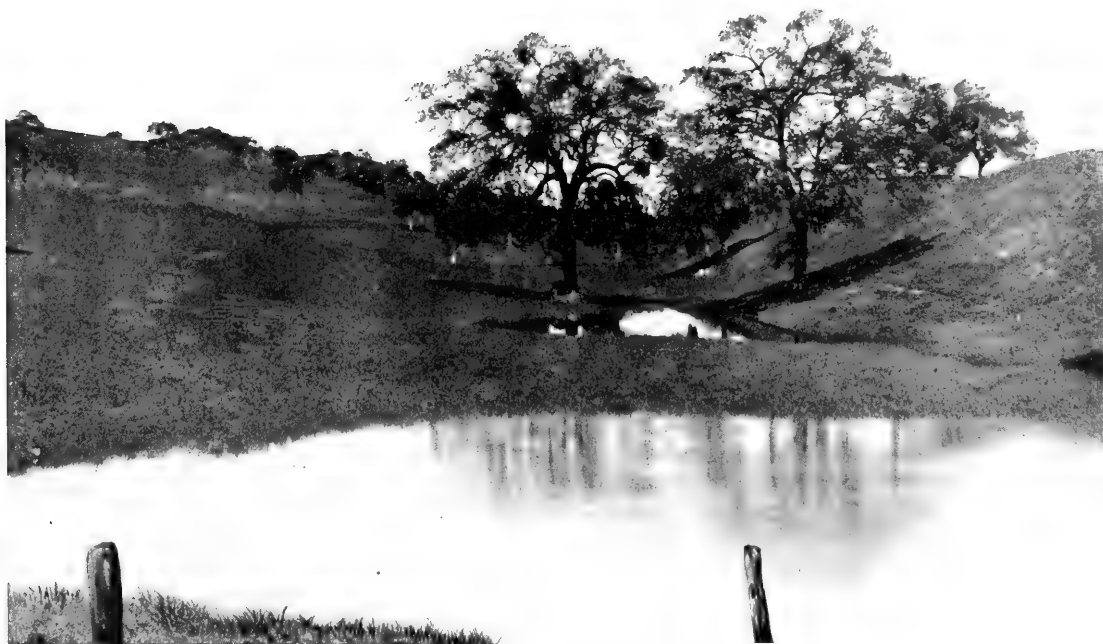
B. Ponds along Rift near San Benito. H. W. F.

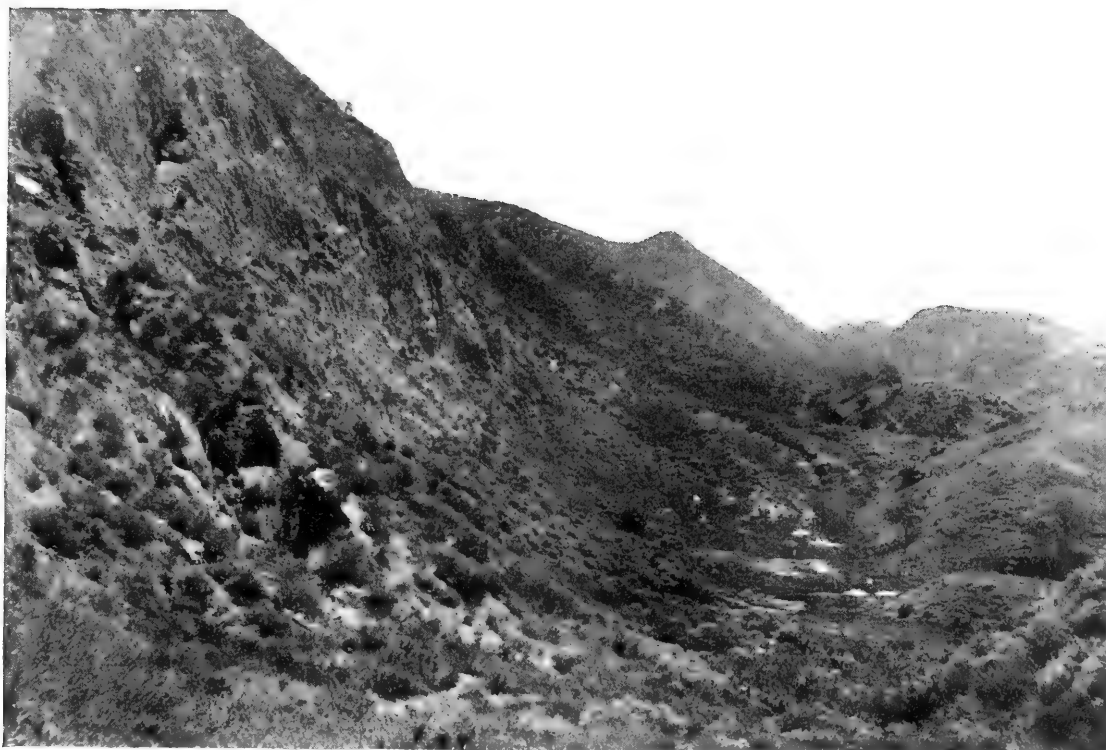
A. The Rift 2 miles south of Dry Lake Valley, San Benito County. H. W. F.

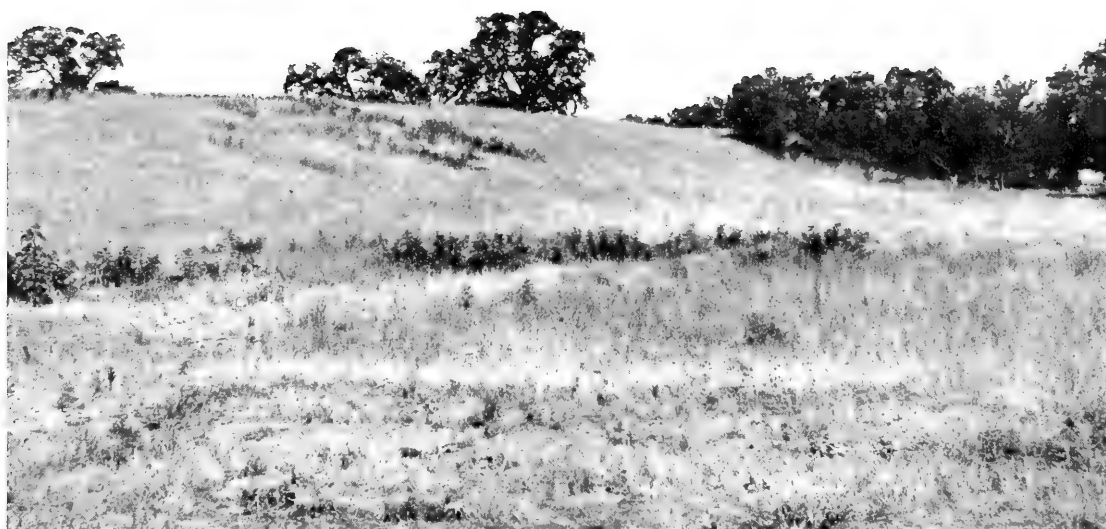
The Rift can be traced thru the hills at the head of the Cholame Valley by its characteristic features, as well as by bluffs which are undergoing rapid erosion. It crosses the road a mile west of Parkfield and exhibits here a regularly rounded ridge 200 feet wide and 20 feet high at the most elevated point. (Plate 19B.) That the ridge must be hundreds of years old is shown by the great oak trees that are growing upon it. One white oak is fully 8 feet thru. Large springs mark the fissure at this point, and are found along it the whole length of the Cholame Valley. According to a resident, the Rift opened along the ridge in the earthquake of 1901, the opening being distinctly traceable for several miles. Southeasterly from the point just described thru the Cholame Valley, there appears no very prominent ridge or escarpment, altho springs and cienegas, marking a gentle swell in the flat open surface of the valley, indicate the line of the Rift.

B. Ancient scarp on the line of the Rift a mile west of Parkfield, Cholame Valley. H. W. F.

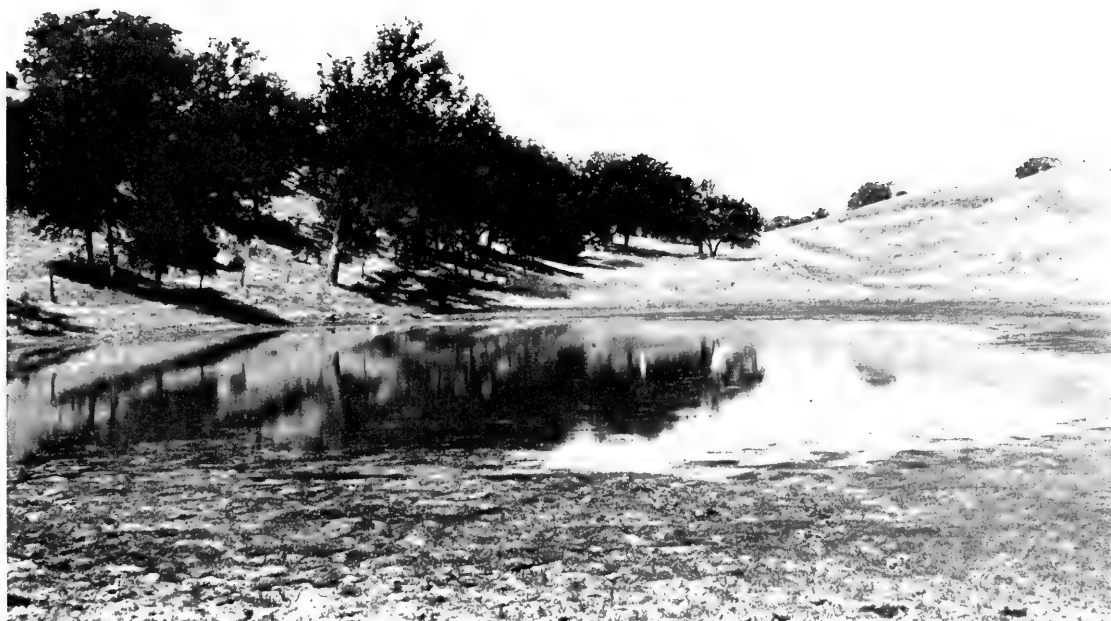
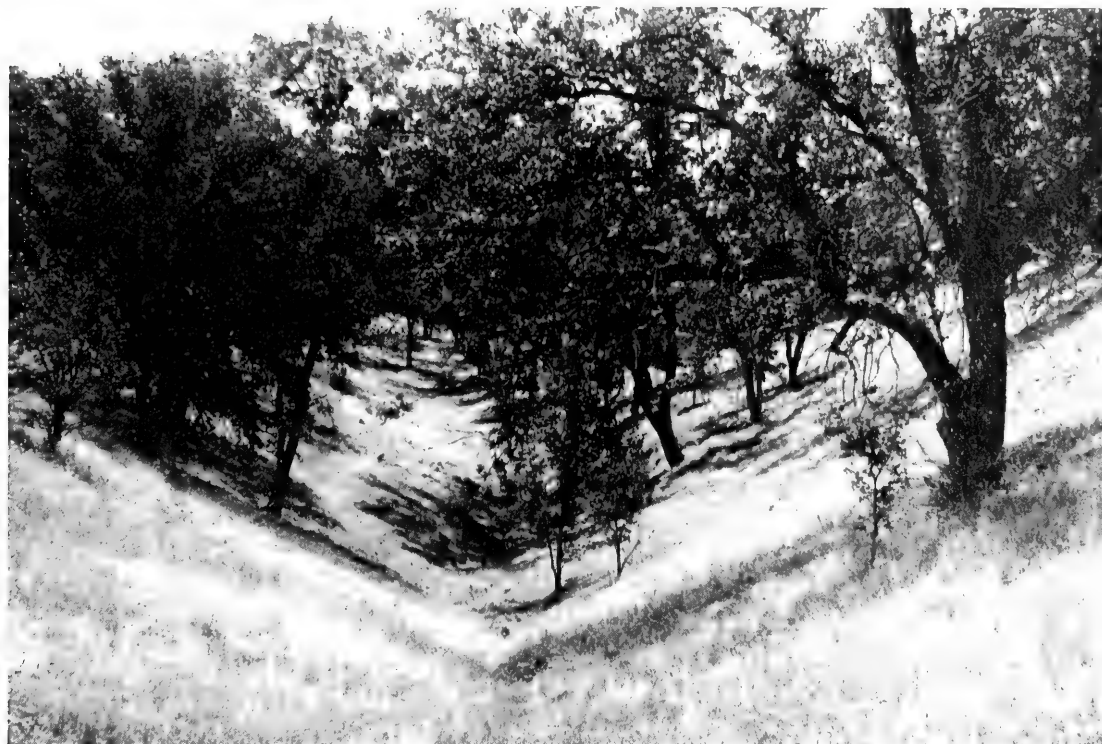
A. A branch of the Rift 2 miles southeast of Parkfield, Cholame Valley. H. W. F.

B. Another view of the same. H. W. F.

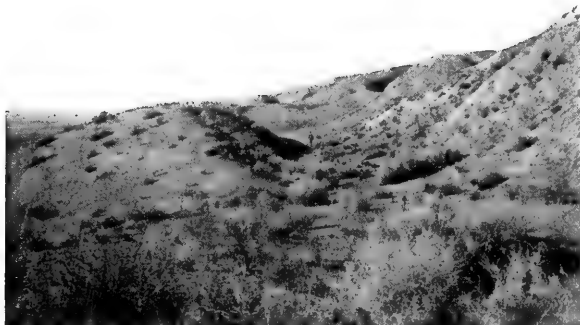
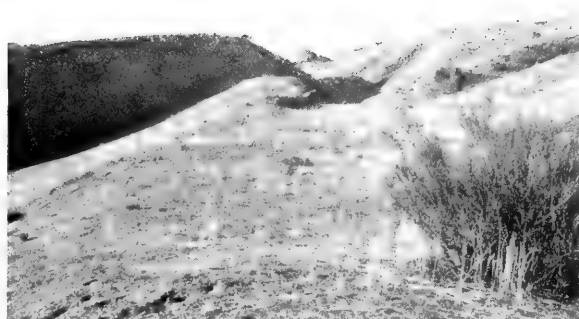
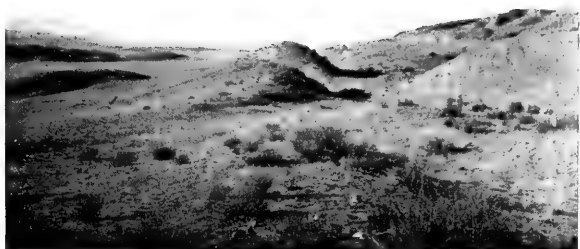
A. Rift, northeast side Carissa Plain. A. C. L., Jan., 1906.

B. Rift, northeast side Carissa Plain. A. C. L., Jan., 1906.

C. Rift, northeast side Carissa Plain. A. C. L., Jan., 1906.

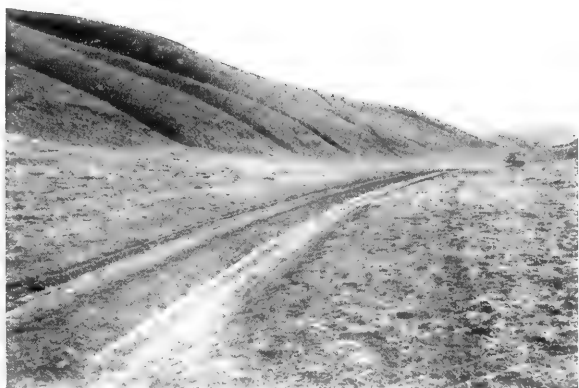
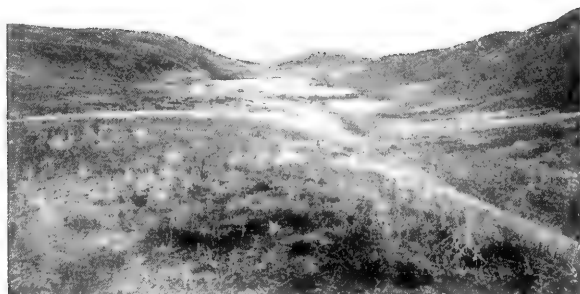
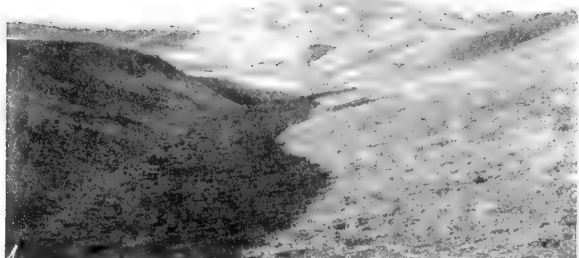
D. Rift, just beyond southeast end Carissa Plain. A. C. L., Jan., 1906.

E. Rift, just beyond southeast end Carissa Plain. A. C. L., Jan., 1906.

F. Rift, just beyond southeast end Carissa Plain. A. C. L., Jan., 1906.

A gentle divide separates the southern end of the Carissa Plain from a long narrow sink extending along the Rift line toward the southeast. (Plate 21D, E, F.) This sink includes an area 6 miles long and in places its drainage is fully 3 miles wide. Several deprest alkali flats, covered with water during the wet season, receive the scanty run-off of this dry region. These depressions are several hundred feet wide and are bordered upon opposite sides by quite sharp bluffs, in some places 100 feet high. The phenomena suggest the sinking of long narrow blocks between two walls. This reach of 6 miles between the ranches of Job and Emerson is one of the most interesting areas examined. The larger scarps belong to some ancient disturbance, while the last one, probably dating from 1857, is marked by features comparatively insignificant.

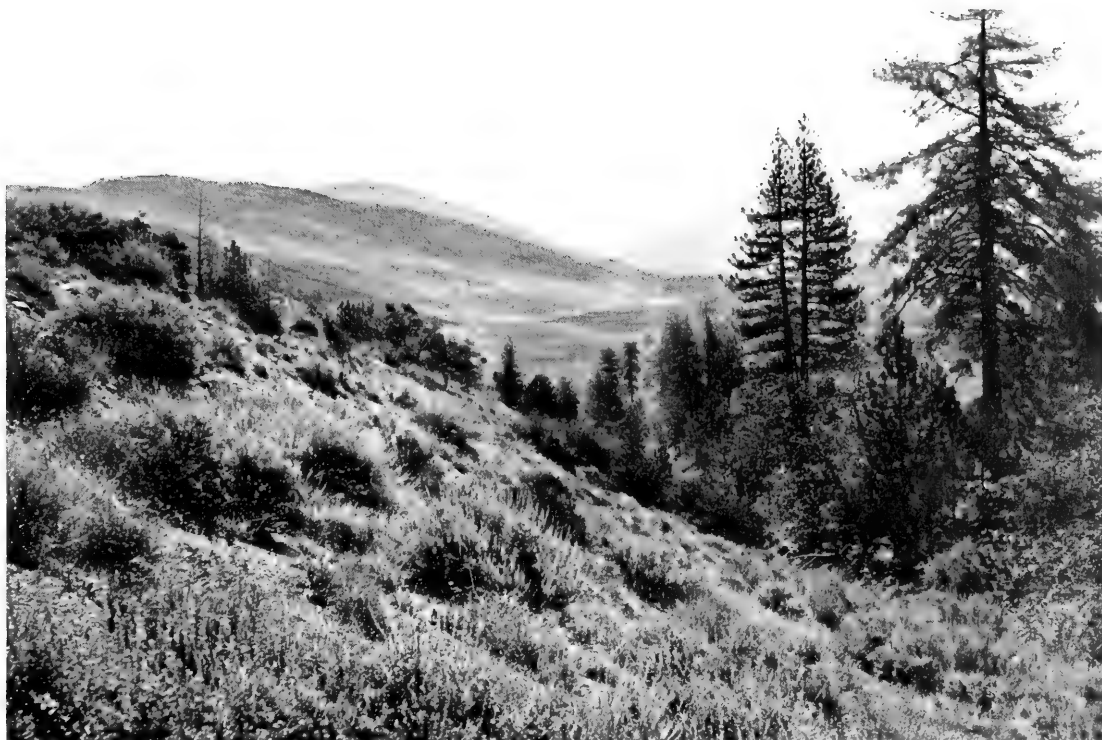
A. Looking south-southeast along the Rift toward Cuddy Valley from head of San Emedio Canyon. H. W. F.

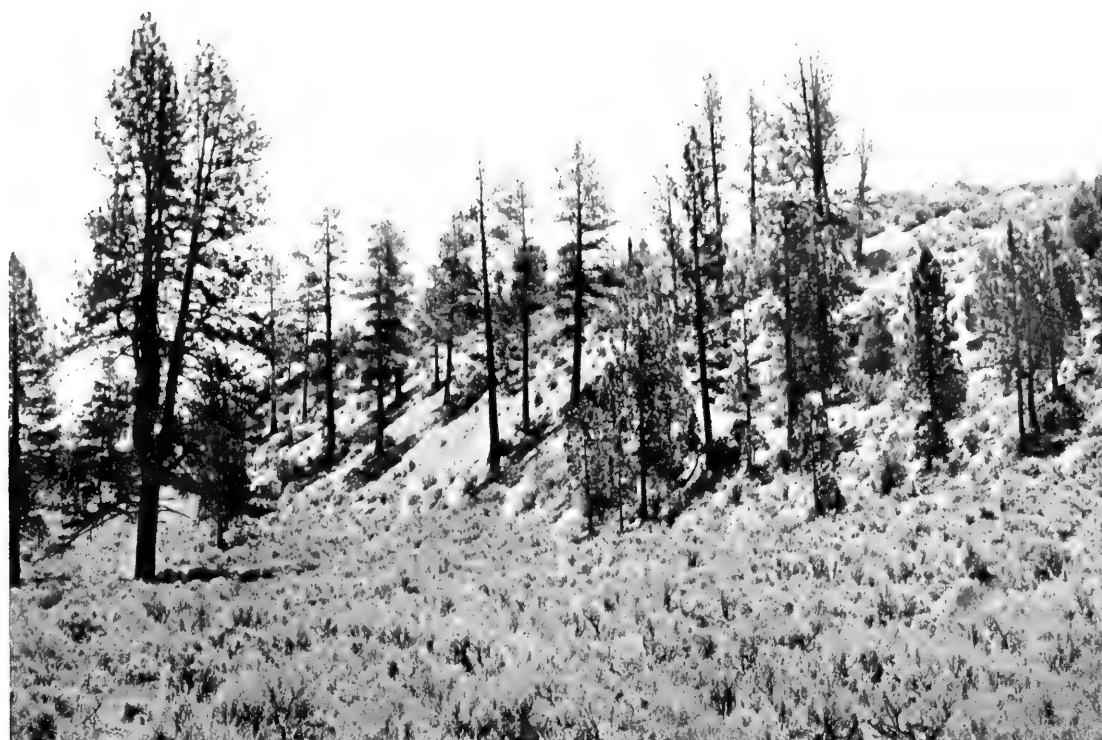
B. Old fault-scarp in Rift. East end of Cuddy Valley. H. W. F.

(See plate 22B.) The fissure follows its northern side for several miles and then, bending a little toward the south, crosses the canyon and takes a course for Tejon Pass. The granitic mountains upon the north of the canyon rise with exceedingly steep slopes, the rocks of which have been thoroly shattered. Immense quantities of rock débris have been brought down the gulches, building up in the main canyon a succession of large and steep débris fans. So much débris has been carried down the canyon that it has been blocked at the point where it turns toward old Fort Tejon, and has thus given rise to Castac Lake. The Rift crosses the divide at the gap known as Tejon Pass. Here there are features due to two movements. Descending a few hundred feet, we find ourselves in a long valley, extending about 10 miles in a direction a little south of east. Springs, marshes, and two ponds mark the line of the Rift from Gorman Station easterly. (Plates 23B and 24A.)

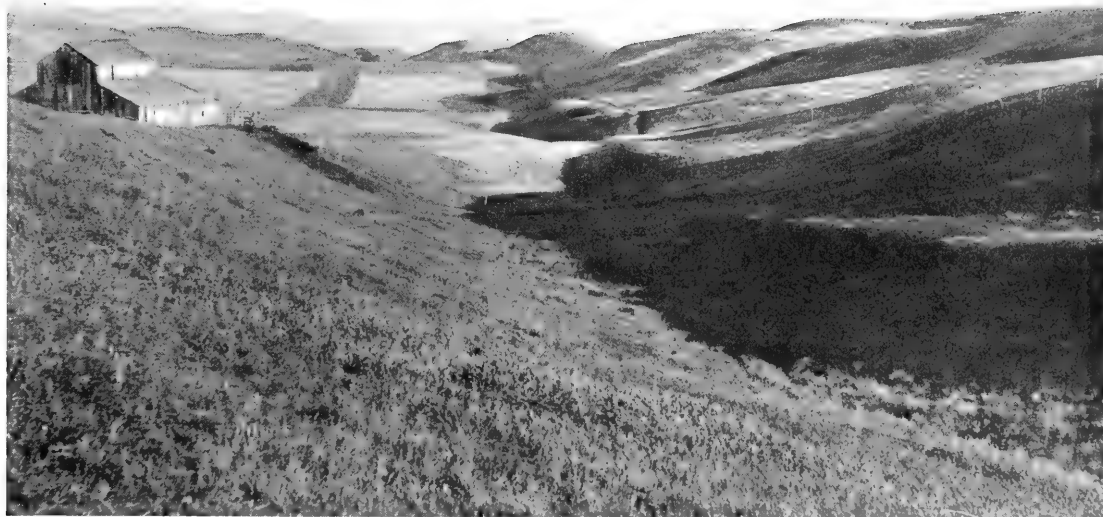
A. Looking northwest along the Rift from Emerson's place, near Pattiway. H. W. F.

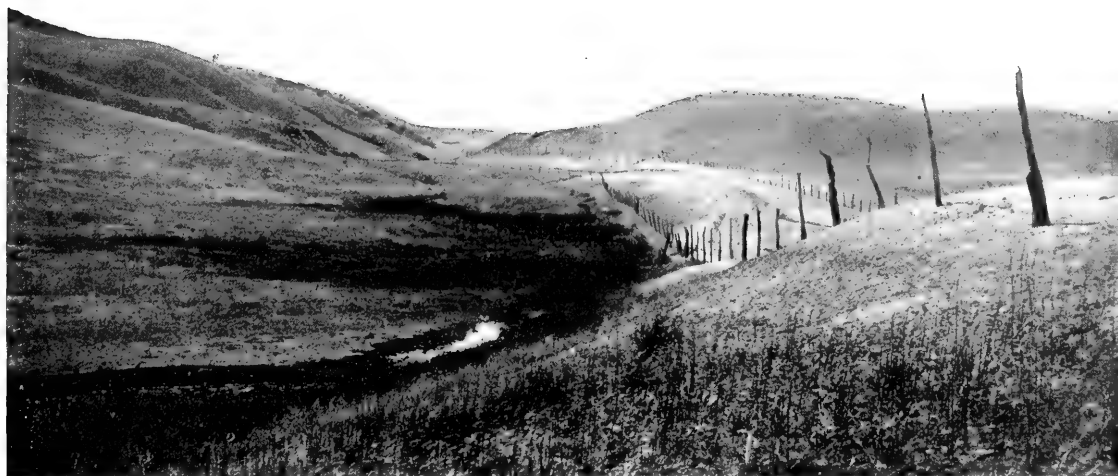
B. Looking east along the Rift from Gorman Station. The low scarp was probably made in 1857. H. W. F.

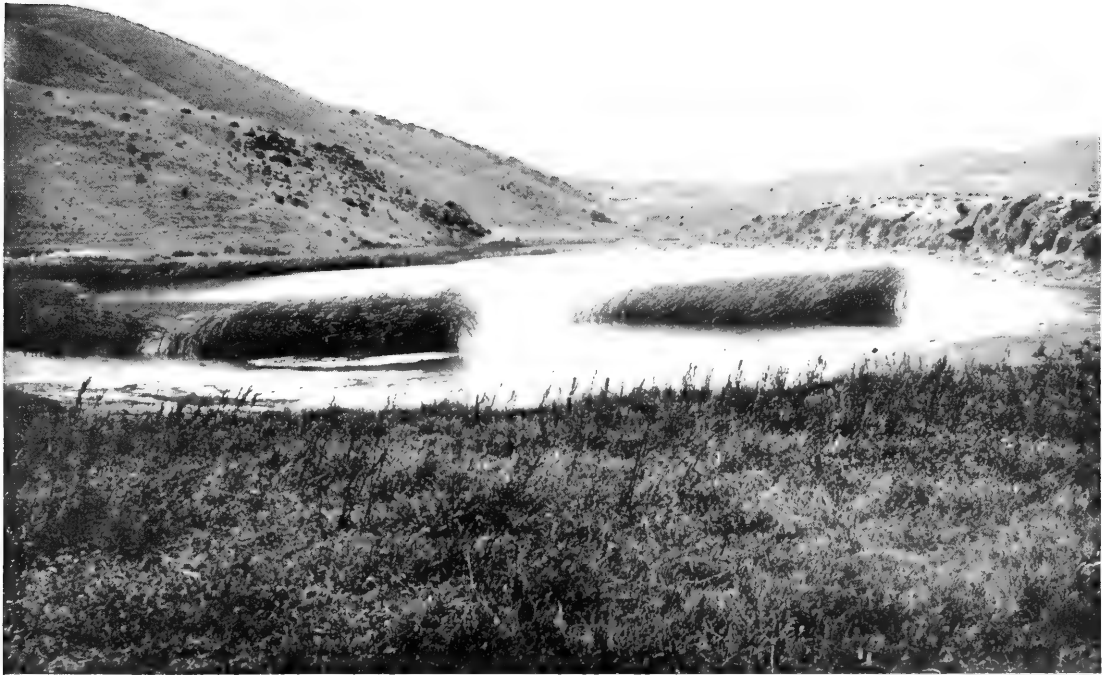
A. Pond and scarp in Rift east of Gorman Station. H. W. F.

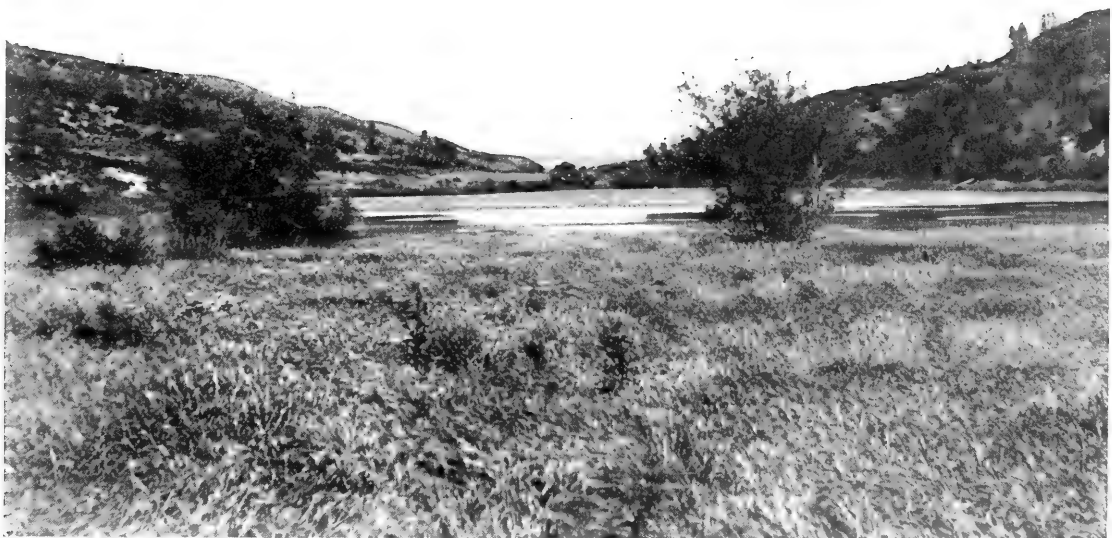
B. Lower Lake Elizabeth. In the Rift. H. W. F.

Lake Elizabeth and Lower Lake (plate 24B) are both due to the blocking of the drainage of two valleys extending along the Rift. These valleys lie on the slope of the range toward the desert (Antelope Valley), but their outlet is southward by a narrow canyon thru the heart of the mountains lying between the desert and Santa Clara River. A low escarpment along the southern side of the valley in which Lake Elizabeth lies, and eastward, is replaced by a lofty rounded ridge which appears to be due to some one of the movements along the old fault. For several miles east of the lake (plate 25A) the distinctive and characteristic features of the Rift are not as easily made out, altho the ridge just mentioned is full of springs and exhibits a widespread landslide topography. Toward the eastern end of this ridge small hollows and a low, indistinct escarpment again appear. The ridge separates Leones Valley, a fertile and well-watered district 5 or 6 miles long, from the open Mojave desert on the north.

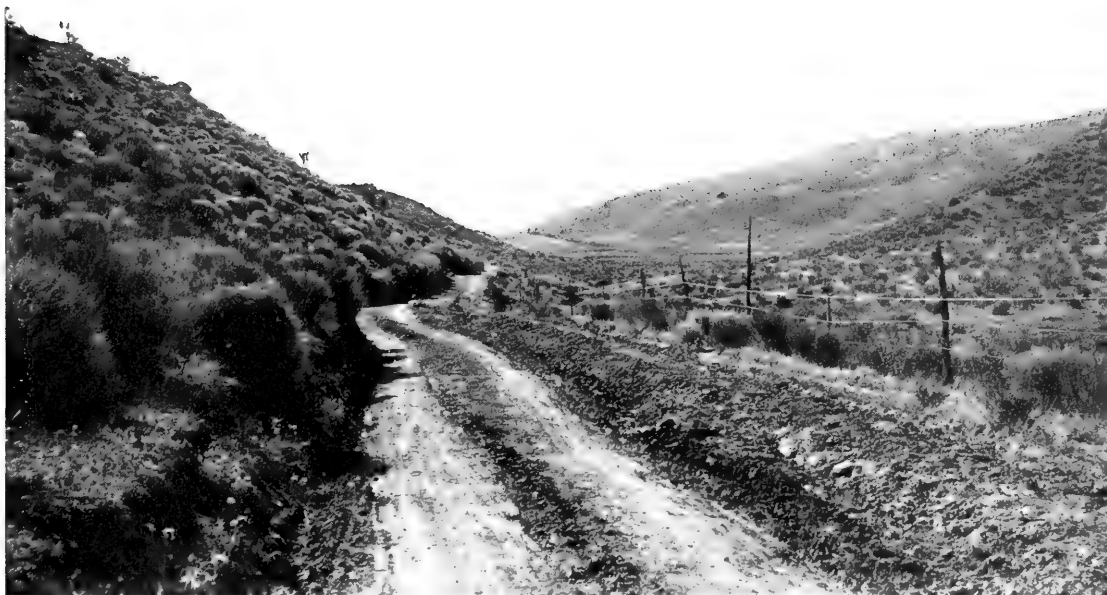
A. Looking southeast along the Rift between Lake Elizabeth and Palmdale. H. W. F.

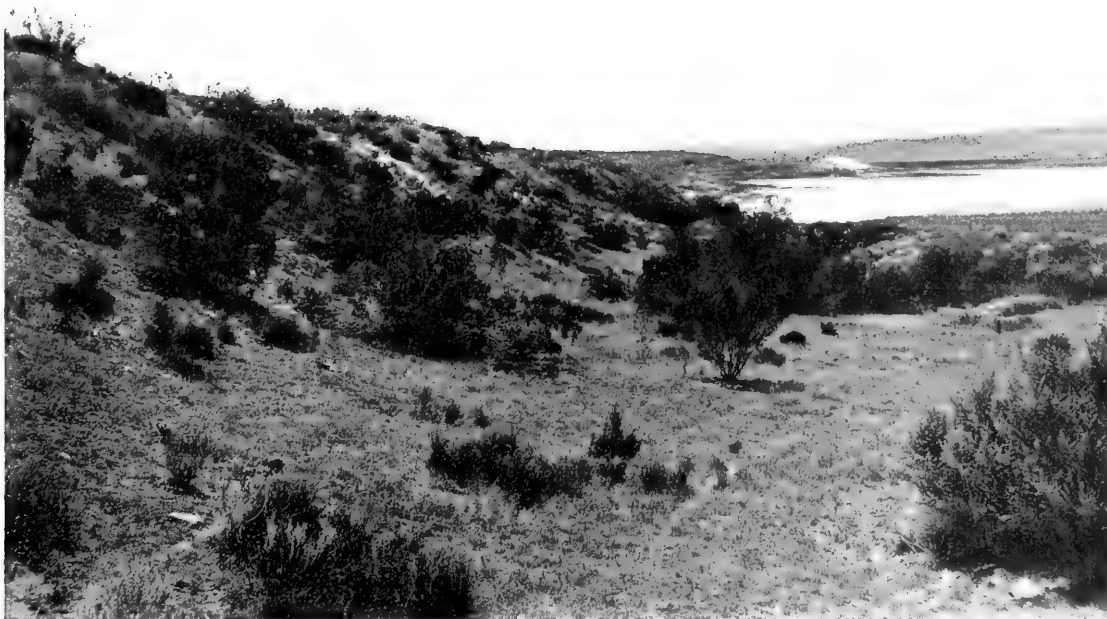
B. Looking east along the Rift scarp west of Palmdale. H. W. F.

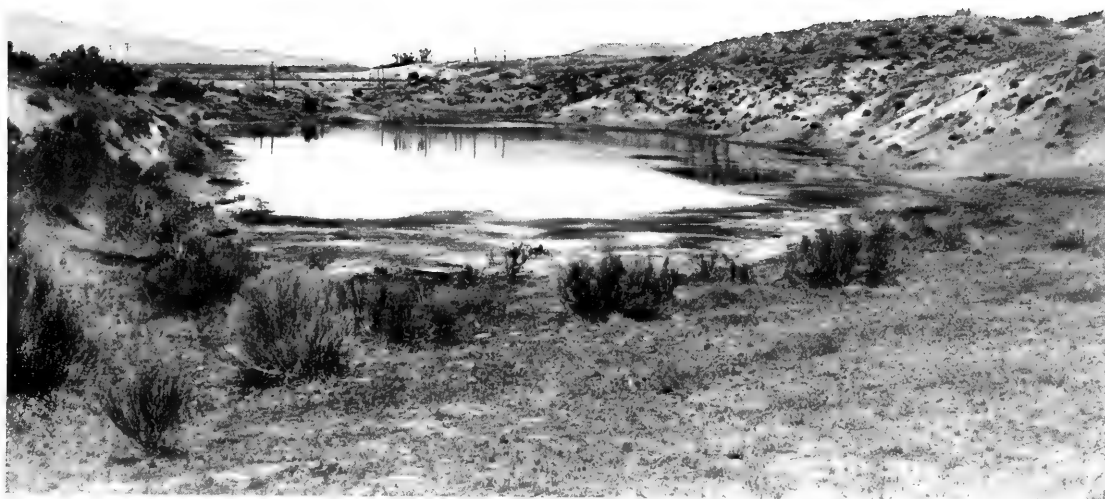
A. Sink between 2 scarps of the Rift a mile south of Palmdale. H. W. F.

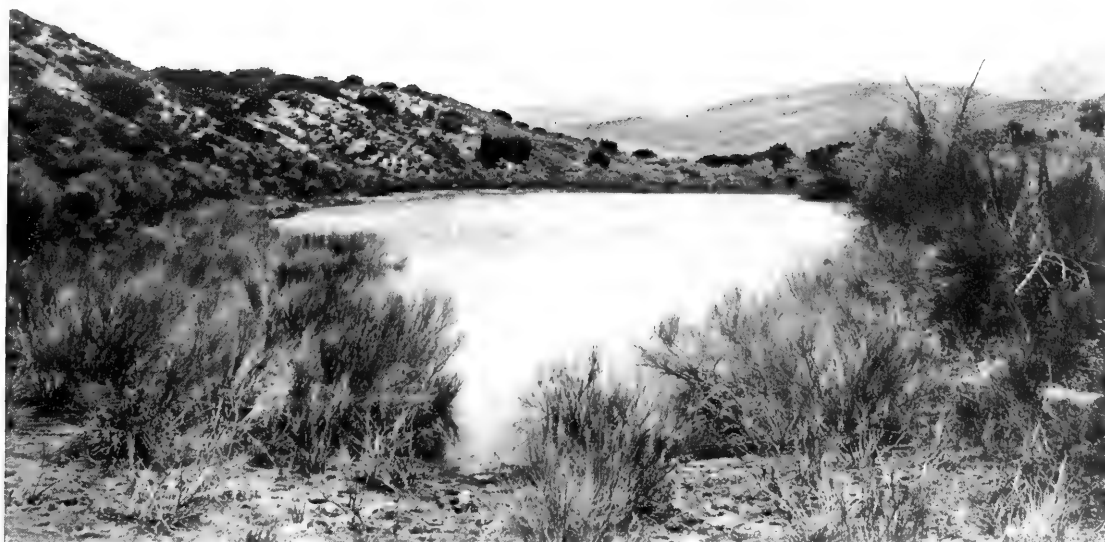
B. Pond in the Rift 2 miles west of Big Rock Creek, Mojave Desert. H. W. F.

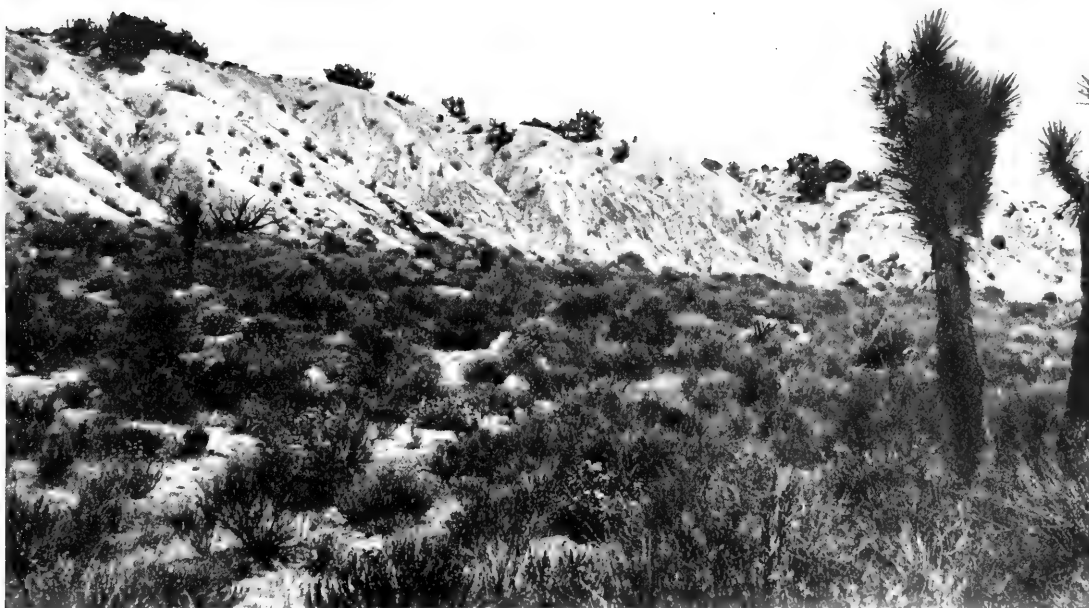
A. Fault-scarp in the Rift. Mojave Desert west of Big Rock Creek. H. W. F.

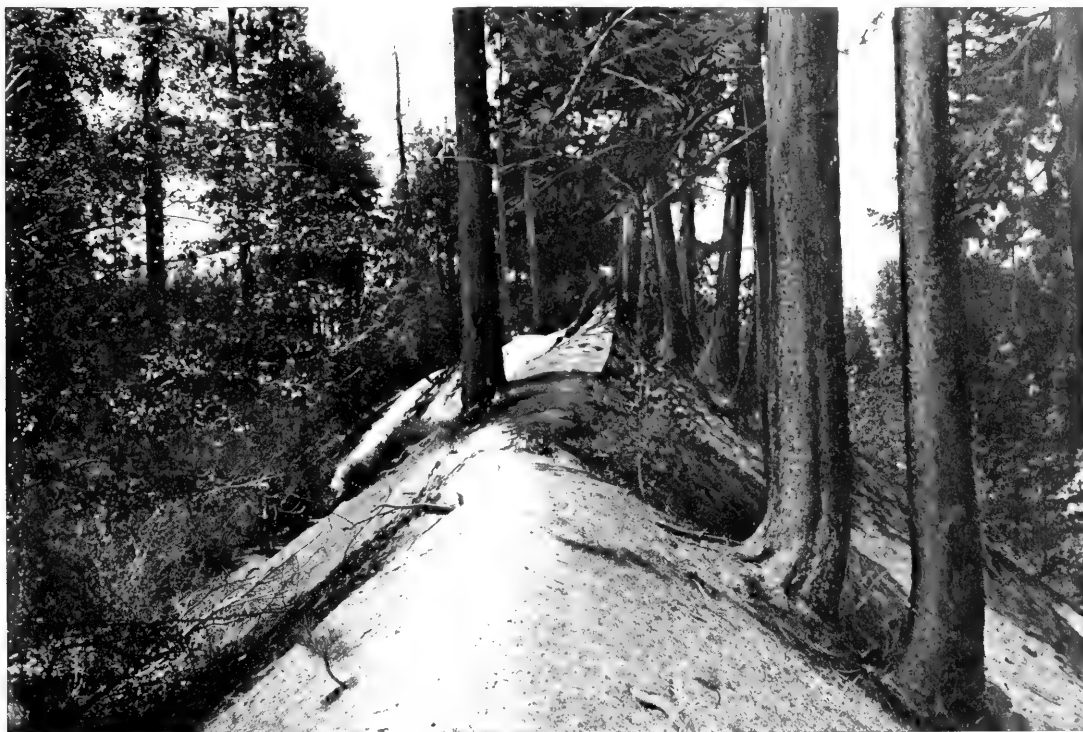
B. Ridge in the Rift near the head of Swartout Valley. H. W. F.

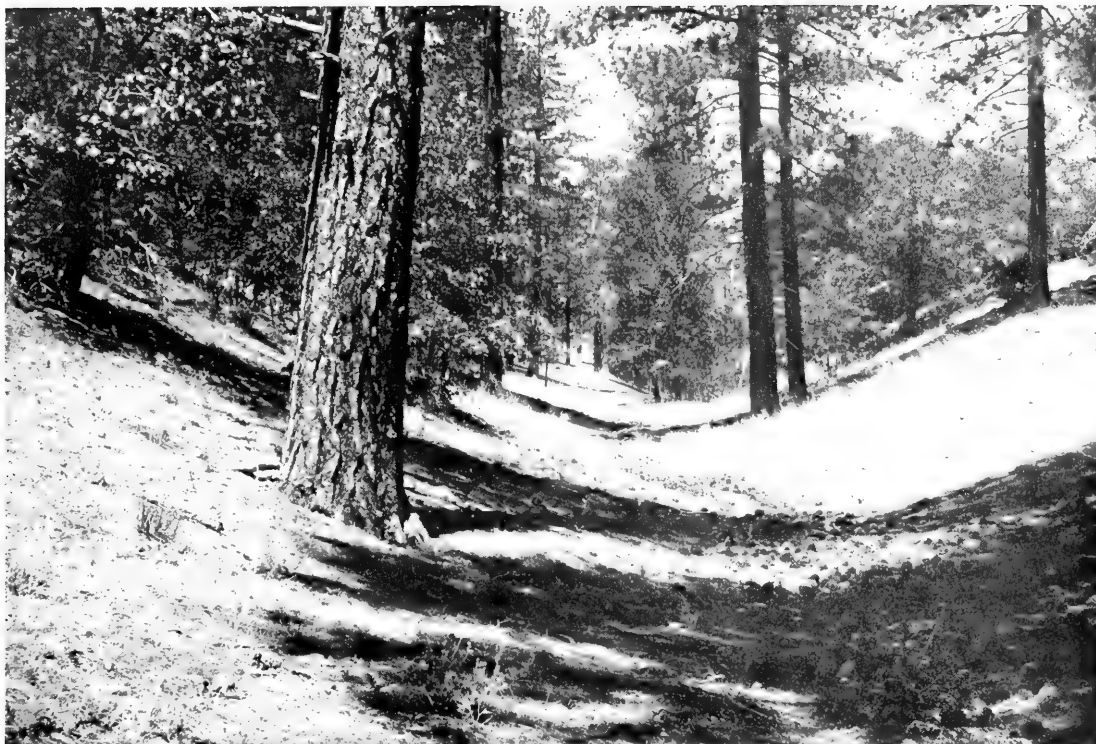
A. The Rift across the mountain crest west of Swartout Valley. North slope of San Gabriel Range. H. W. F.

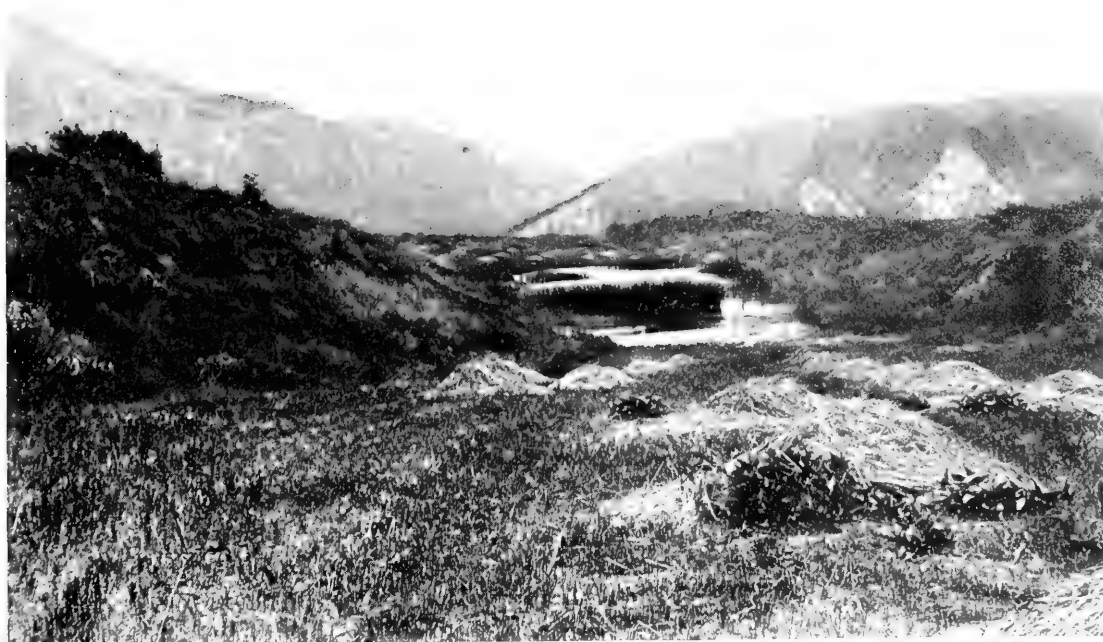
B. Looking southeast from lower end of Lone Pine Canyon across lower end of Cajon Canyon. Lake and meadow due to ridge in Rift. H. W. F.

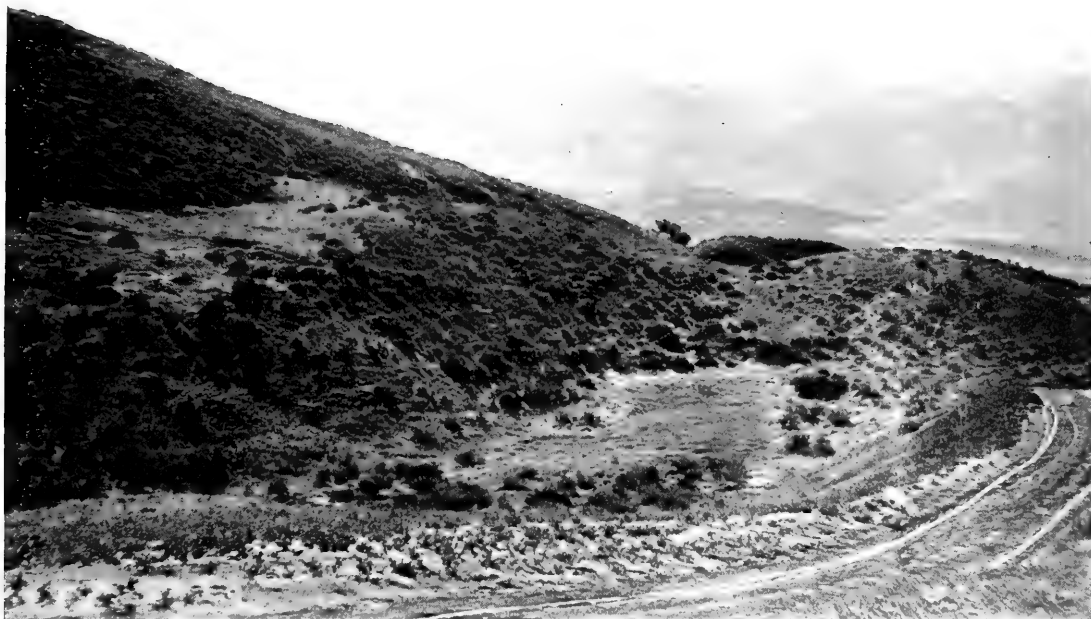
A. Looking west along the Rift from Cajon Pass, showing double scarp. H. W. F.

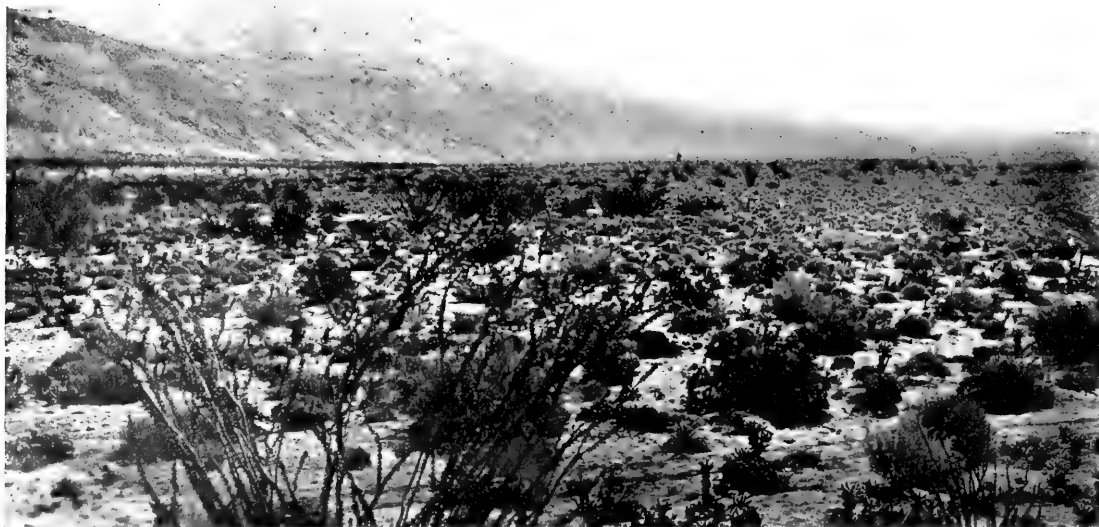
A. Looking east across Borego Valley toward south end of San Jacinto fault-scarp. H. W. F.

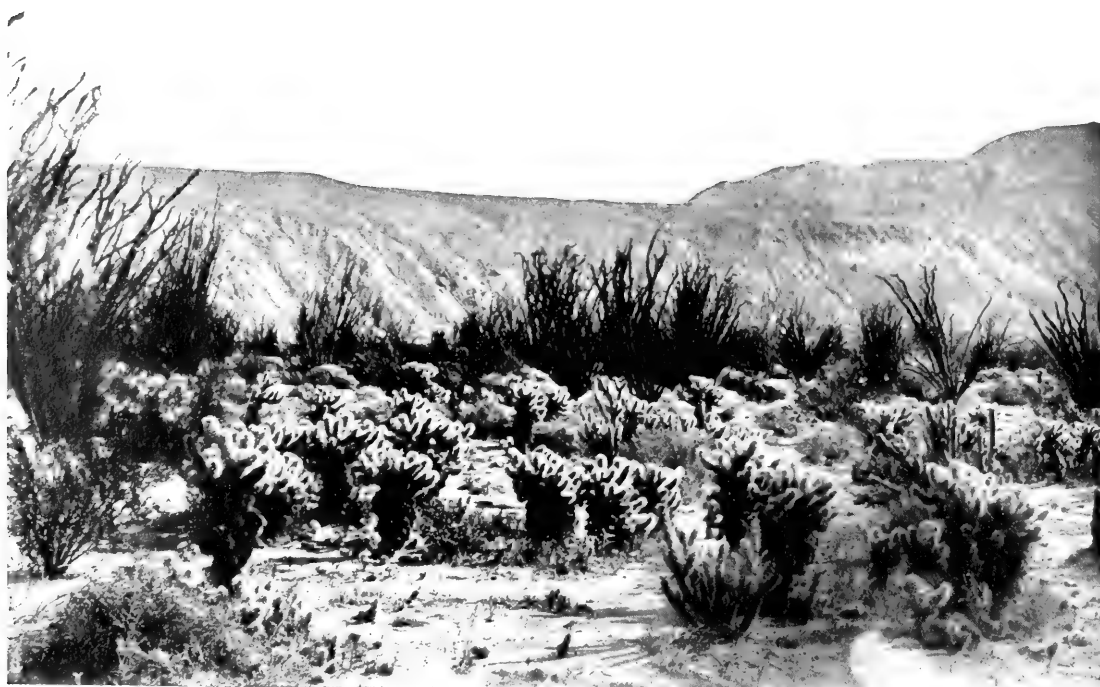
B. A nearer view of the San Jacinto fault-scarp. Upper end of Borego Valley. H. W. F.

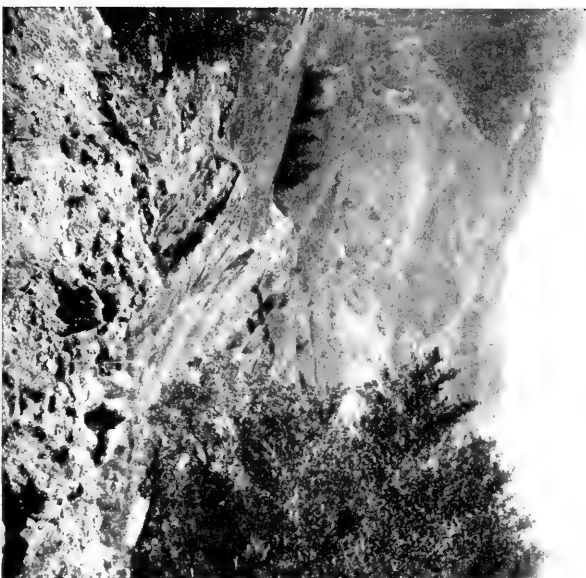
south slope of Telegraph Hill, following for a considerable distance a characteristic fault feature on the steep brushy spurs indicated in plate 31b. Immediately south of the summit of Telegraph Hill the disturbance is the most pronounced, being accompanied apparently by an upthrow on the west side, resulting in a sharp-crested ridge some 4 feet high. It is possible, however, that this ridge is not the result of the recent disturbance, but of a former one, modified into a more acute form by the shaking off of the sod. (See plate 31c.) From the summit of Telegraph Hill a bearing was taken over the entire length of the line down to Shelter Cove: N. 25° W. Projecting the line north from the hill on the azimuth, it appears to head for a number of high mountains of the King's Peak Range, altho no visible traces of the disturbance are found north of Telegraph Hill. Immediately north of its crest is the upper end of a great hopper-like landslide, clean swept for over a thousand feet. The fault-trace is entirely obliterated by this slide. The exact location of the fault north of Telegraph Hill was not ascertained. Under the

C. Looking south-southeast from Telegraph Hill along fault-trace marked by sharp-crested ridge in foreground, with upthrow of $4 \pm$ feet. F. E. M.

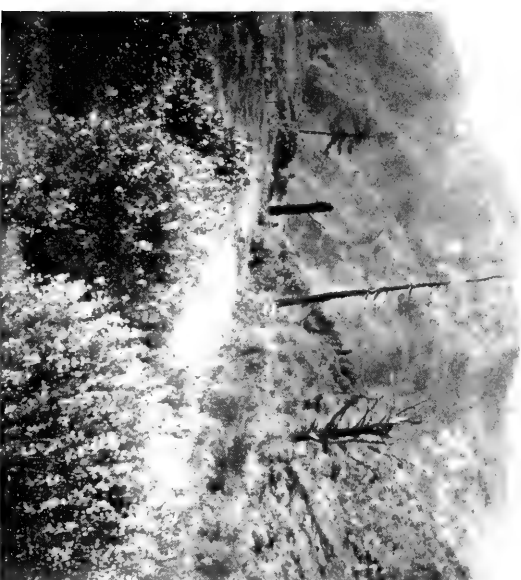
D. Looking north-northwest along main fault marked by small ridges on spurs of Telegraph Hill. F. E. M.
